## UNITED STATES ENVIRONMENTAL PROTECTION AGENCY Region I - EPA New England

SUBJECT: Full Compliance Evaluation of Organic Dyes and Pigments LLC in East

Providence, RI

# PHOTO LOG

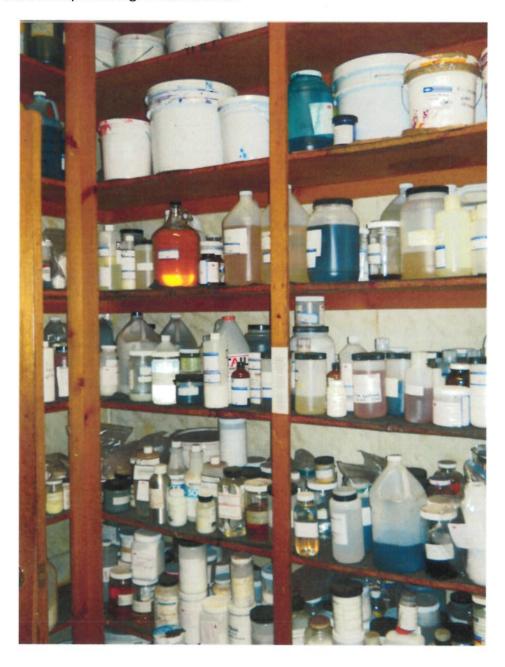
The tour started at the facilities research and development ("R&D") labs. In the area of the R&D labs was space for small sample storage. Ms. Turner explained that the labs test products to determine if they will meet customer specifications. Many small samples of dyes are cataloged and stored on-site. See photos 1 and 2.

Photo 1: Small Sample Storage Area 10:15 am

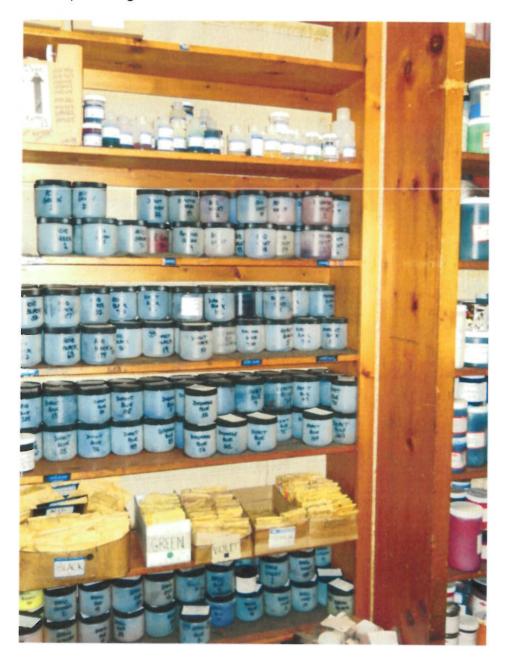
Photo 2: Small sample storage area 10:16 am

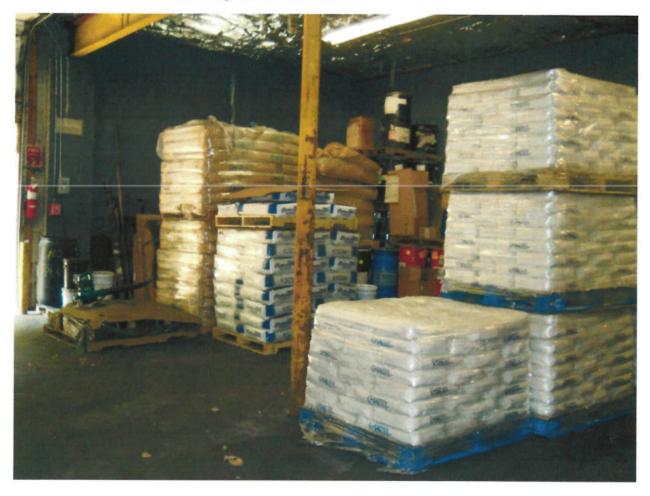
Behind the R&D laboratory is the heated chemical storage area. At the time of the inspection large garage-type doors were open in this area. The area is used to store wet and dry chemicals that are primarily raw materials. For example Ms. Kudarauskas noted the following chemicals stored in this area:

- Bags of sodium acetate
- Bags of citric acid anhydrous
- Bags of malodextrin
- Drums labeled APG-5265

Photo 3: Heated chemical storage area 10:17 am

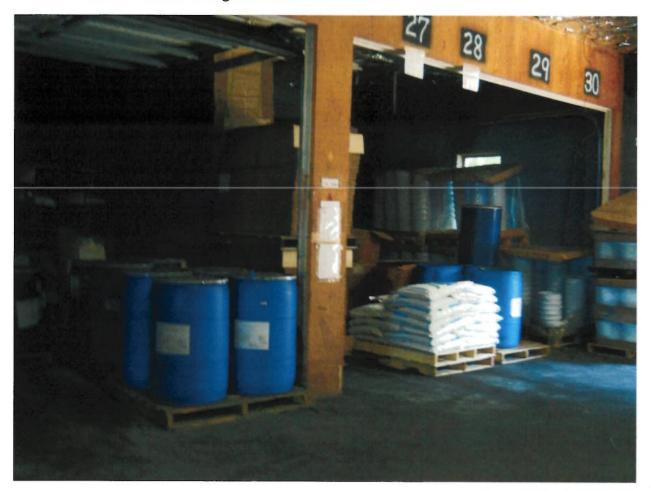
Photo 4: Heated chemical storage area 10:17 am

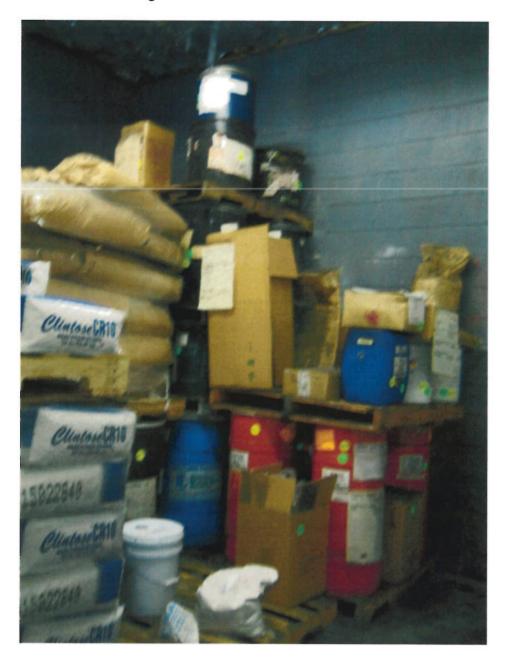
Photo 5: Heated chemical storage area 10:20 am

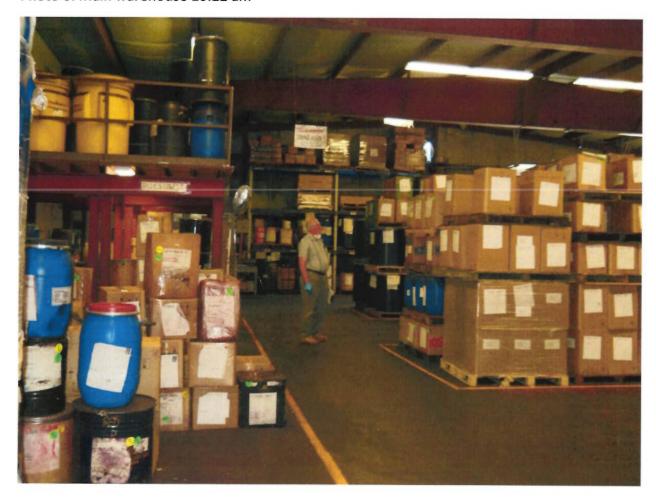
The inspectors were then led to the building next door. This building is the main warehouse and is used to store most of the raw materials. See photo 6.

Photo 6: Main warehouse 10:22 am

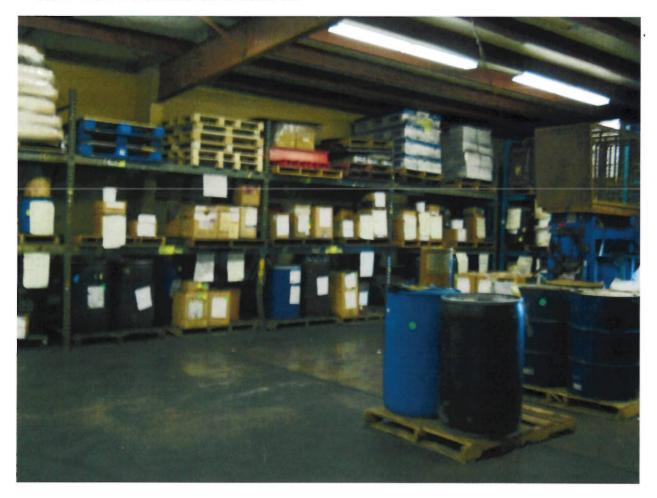
The annex area was on the other side of the main warehouse building. This area is primarily used to store finished products. See photo 7.

Photo 7: Main Warehouse Annex 10:26 am

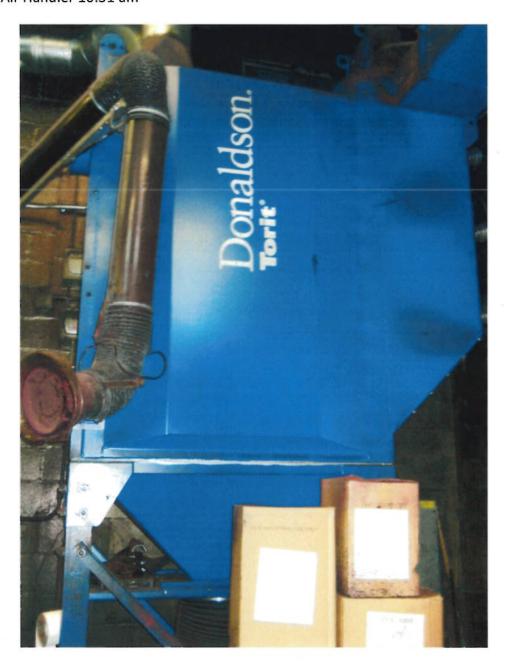
4 large mixers in the first room. Ms. Kudarauskas saw HVAC-type ductwork which pulled air from above the mixers. See photo 8. Elephant trunk type of hoods were pulling air from the areas where powdered dyes would be added. All ductwork vented to a common air handling system. The air system was a Donaldson Torit system. See photo 9. Ms Turner described the air handling system as an air filtration system. The air filtration system then vented the air back into the room. Next to the air filtration system is a monitor which displays the pressure on the air system. At the time of the inspection the pressure reading on the unit was 0.9.

Photo 9: Air Handler 10:31 am

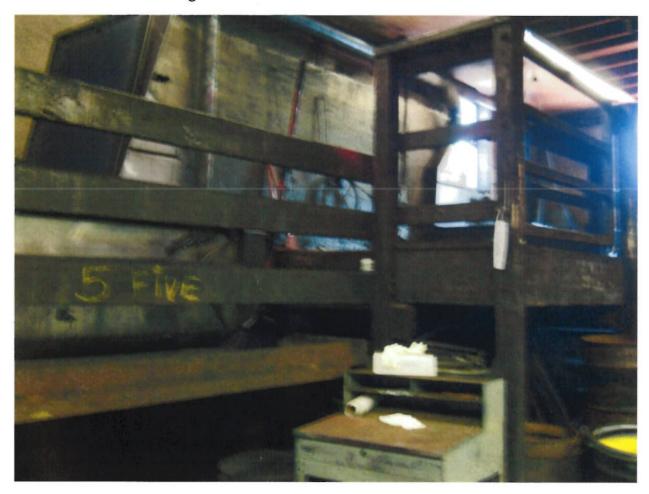
The inspectors continued into a second room that contained two smaller mixers and a separate air filtration system. See photo 10. The pressure reading on this air filtration system was a negative number (-3.1). Several drum mixers were also in this area.

Photo 10: Additional Mixing Tanks

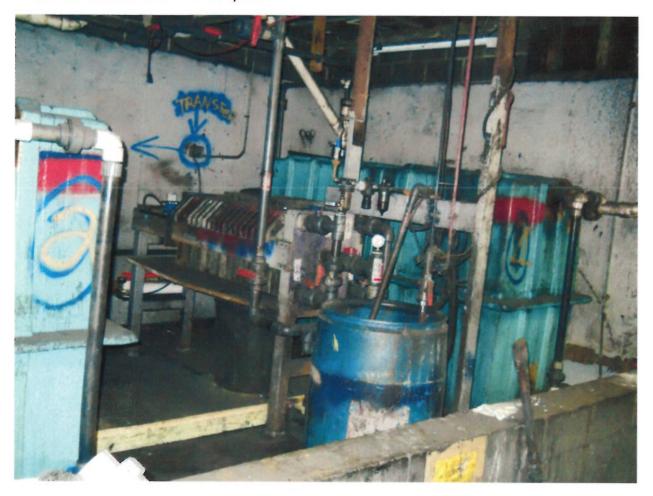
Ms. Turner then led the inspectors to the basement where the wastewater filtration system is located. See photo 11. The wastewater system is operated in batches. The wastewater is collected in the basement. When enough wastewater is collected, the wastewater passes through filters. A concrete berm encircles the entire wastewater system. Each filter is used once and the material that remains on the filter is treated as hazardous waste.

.Photo 11: Wastewater filtration system
